MEMORANDUM

SUBJECT: Resampling of municipal drinking water wells located

near the Air Center Inc. site, in Oklahoma City, OK

TDD # F-6-8808-36, CERCLIS # OKD980750319,

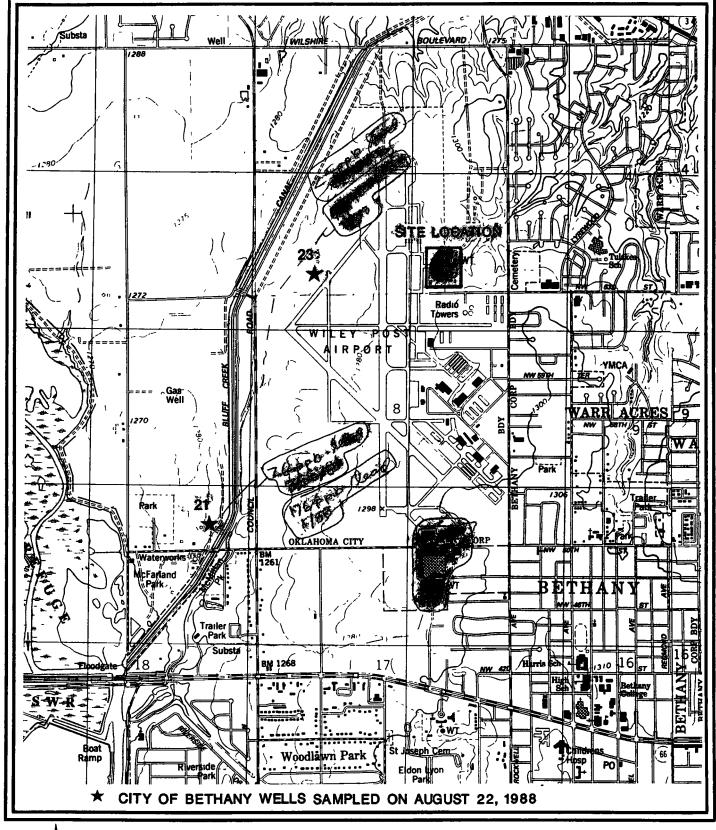
Sample Location Map AIR CENTER INC. OKLAHOMA CITY, OK TDD NO. F-6-8808-36 CERCLIS NO. OKD980750319 BETHANY, OK BRITTON, OK

On August 22, 1988, FIT team members, Ravinder Joseph (team leader), and Tom Rountree (site safety officer) resampled City of Bethany municipal drinking water wells # 21 and # 23. Well # 21 is located approximately 1.4 miles southwest of the site, and well # 23 is located approximately 3000 feet west of the site. A copy of

Analysis of the August 1988 samples indicates the presence of low levels of lead in well # 21. Lead was not detected in well # 23. The levels detected in well # 21 are well below the current Primary Drinking Water Standard of 50 ppb, and would still fall below the proposed standard of 20 ppb (see Attachment A for complete sample results). Although lead has been detected in on-site samples in the past, lead was not present in on-site samples collected by the FIT in January of 1988.

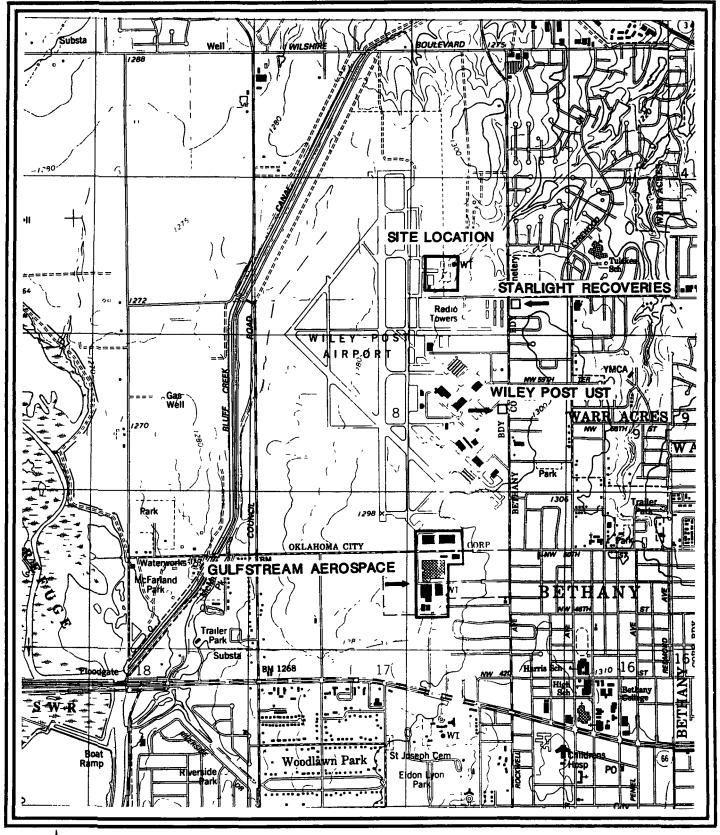
Neighboring Industries to Air Center, Inc.

In response to TDD # F-6-8808-35, during the August 22, 1988 trip, FIT collected information in an attempt to determine additional potential contributors of lead contamination. Information was collected through drive bys of local industry and through the contacting of a state official. The attached map, titled Neighboring Industries, indicates their location and proximity to Air Center. FIT conducted off-site reconnaissance inspections of Gulfstream Aerospace Inc, the Wiley Post Airport, and Starlight Recoveries, all located nearby the Air Center site. FIT did not observe any noticeable problems from off-site which could contribute to surface migration of contaminants. Off-site photographs of the Wiley Post tank battery and Gulfstream are attached. Additional information regarding the operations of Starlight Recoveries was not obtained.

While observing from offsite, FIT saw what appeared to be a underground storage tank battery used for the storage of jet fuel. Information obtained from the Wiley Post authorities confirmed the presence of underground storage tanks. The Wiley Post Airport has a total of 17 underground storage tanks on-site for storing jet fuel. The total combined capacities of these tanks is estimated to be 228,000 gallons. The tanks are between 2-28 years old. It is not known whether any of these tanks have been leak tested. The potential exists for Wiley Post Airport to contribute to the lead contamination of groundwater as lead is a constituent of jet fuel.

FIT also contacted Tom Black with the Oklahoma Water Resources Board to obtain the following additional information on Gulfstream Aerospace Corporation (see Attachment B for file information obtained from Mr. Black). Gulfstream is a manufacturer of aircraft parts and is located at 5001 North Rockwell, Bethany, OK 73008. is a generator of chromic acid, jet fuel and dried paint waste containing zinc chromate and solvents. Lead contaminated foundry sand was found dumped on-site during sampling by OSDH in May 1986. Spills of chromic acid and hydrofluoric acid were also reported in May 1986. Sampling by OSDH in May 1986, detected lead concentrations as high as 4850 ppm and chromium as high as 1281 ppm in soil samples. In addition, there are seven underground storage tanks at Gulfstream containing unleaded gas, diesel, and jet fuel. The tanks have a combined total capacity of 48,000 gallons. The tanks are between 15-26 years old. It is not known if any of these tanks have been leak tested, as it was only recently that the Oklahoma Corporation Commissions UST Department required test results to be submitted as part of the reporting requirement for underground storage tanks. The potential exists for Gulfstream to contribute to the lead and chromium contamination.

While it is unclear if Air Center is contributing to groundwater contamination, past sampling has indicated that Air Center has contributed to surface water contamination. It is recommended that the surface water route be further investigated. Furthermore, it is recommended that Gulfstream Aerospace, the Wiley Post Airport and Starlight Recoveries be investigated as possible sources of lead contamination to groundwater. Sampling of all 27 City of Bethany wells would assist in defining the plume and source of contamination accurately.
